# Debris/Ice/TPS Assessment and Integrated Photographic Analysis for Shuttle Mission STS-62

(NASA-TM-109201) DEBRIS/ICE/TPS  
ASSESSMENT AND INTEGRATED  
PHOTOGRAPHIC ANALYSIS FOR SHUTTLE  
MISSION STS-62 Final Report, 2-21  
Mar. 1994 (NASA. Kennedy Space  
Center) 138 p

May 1994

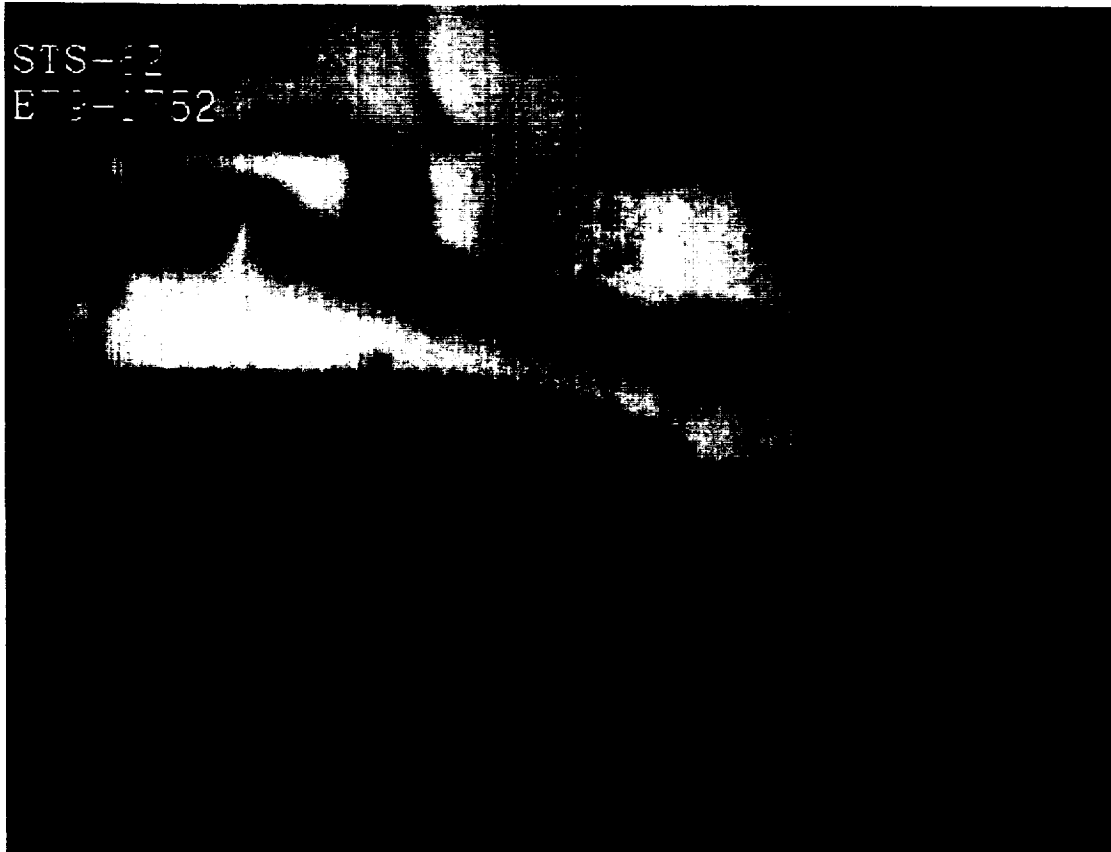
**Figure 2.1.3.1 Debris Near ET Aft Dome During Tower Clear**

Several pieces of orange colored debris were seen near the ET aft dome falling aft during tower clear. The debris had the characteristics of umbilical baggy material. The debris was timed at approximately 4.4 seconds MET on the three camera views. A multicolored piece of debris seen

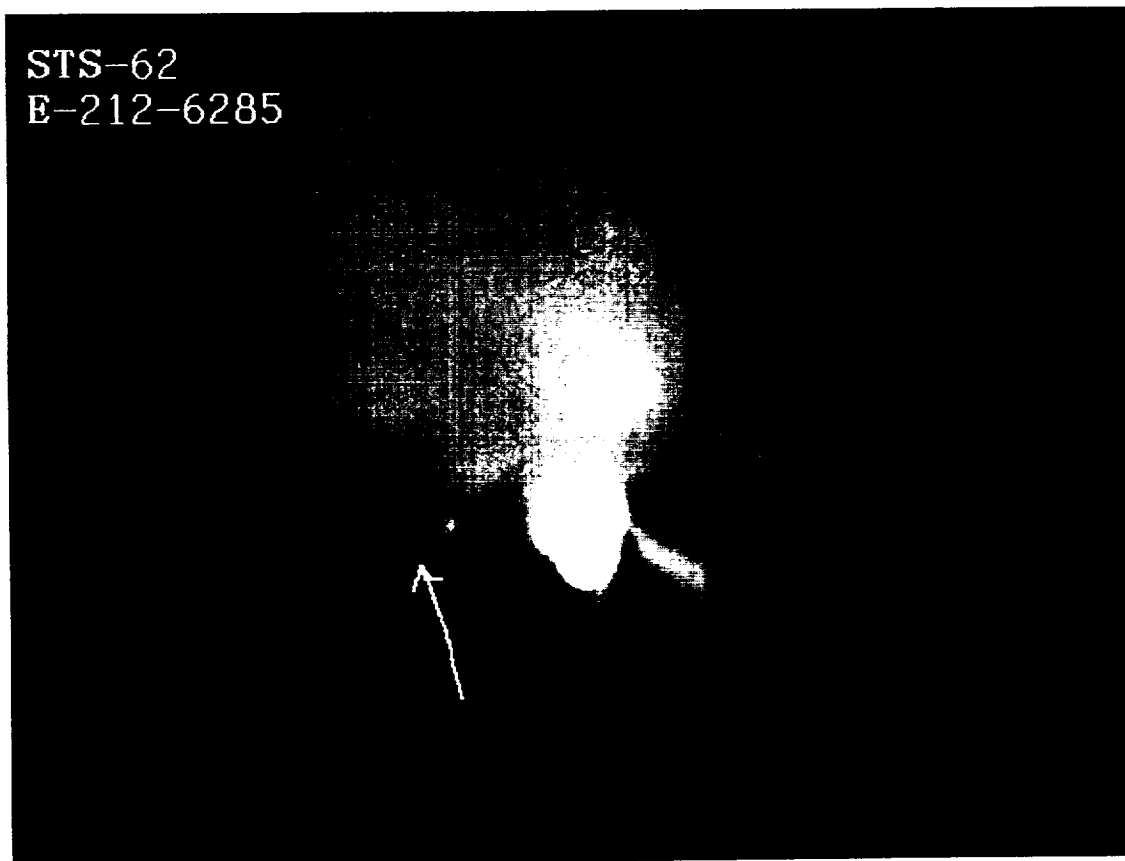
**Figure 2.3.4 Orange Flashes in SRB Plume Prior to SRB Separation**

Several orange flashes were noted in the SRB plume just prior to SRB separation. A orange flash was seen at the interface of the SSME and SRB plumes at approximately 115 seconds MET. An engineer from the JSC Propulsion & Power Division reviewed the films of these flashes and no follow-up action was assigned. A similar orange flash was previously identified on STS-53 and discussions with MSFC personnel at that time indicated that the event was not anomalous.

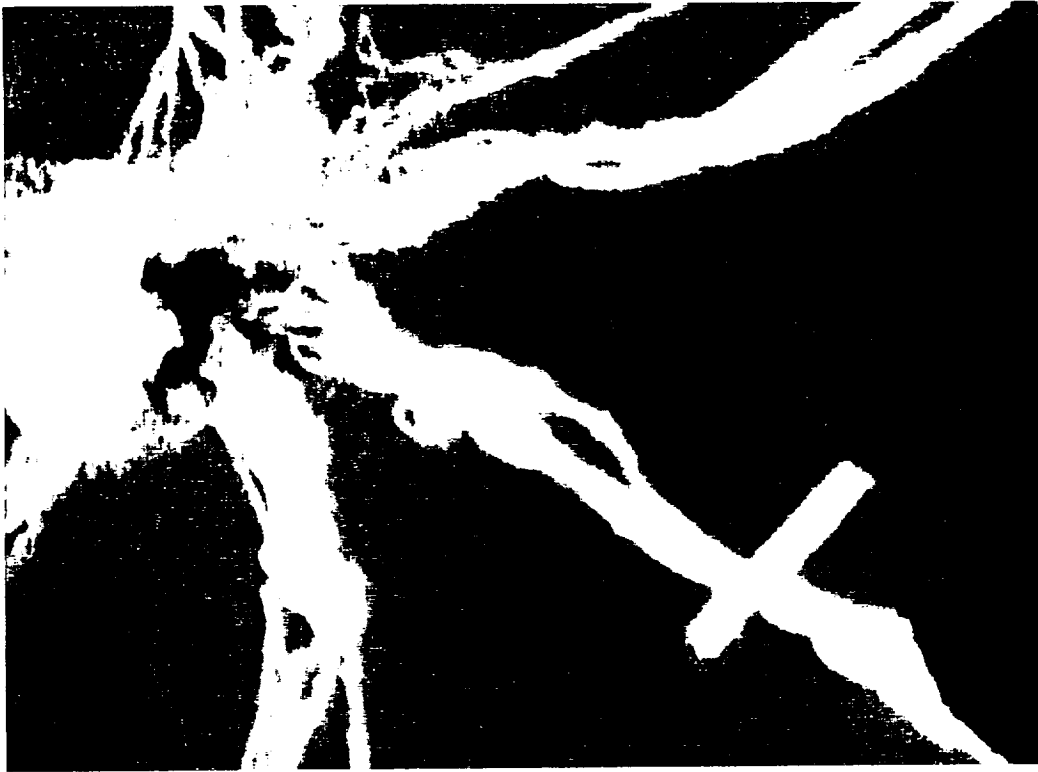
Figure 1: Debris Object from Camera E-302

An unusual debris object was noted from the left SRB main parachute camera after frustum separation. The source of this debris is unknown. Figure 1 shows this debris from camera E-302.

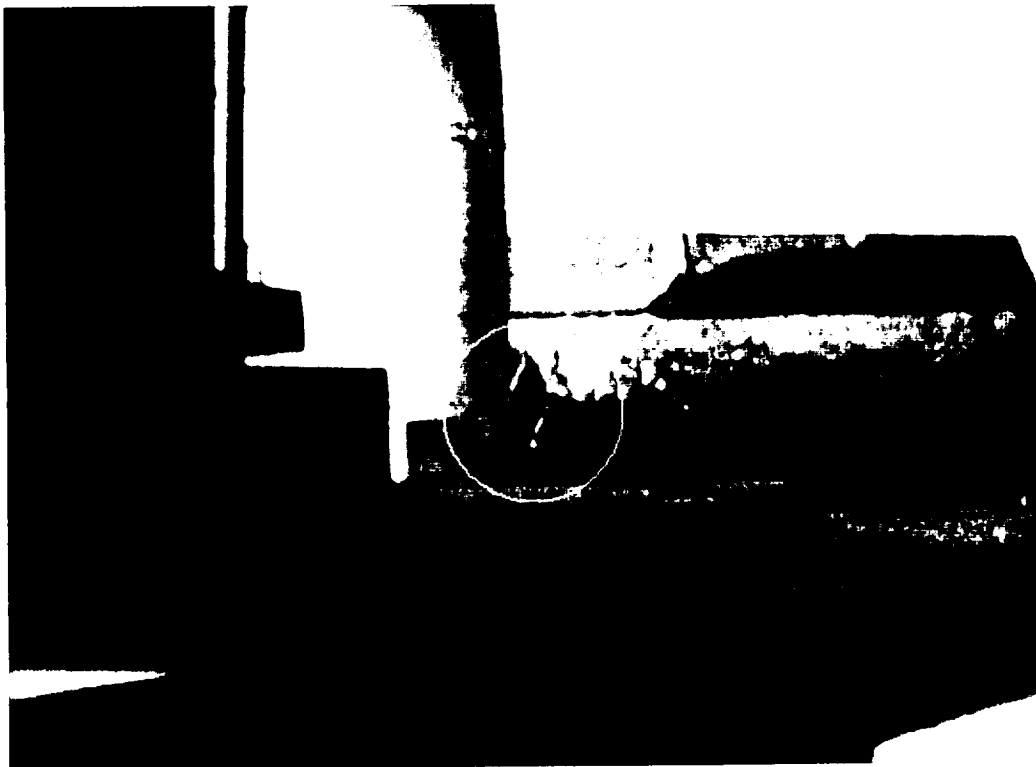
Figure 2: APU Exhaust Port Dripping

Liquid drops were visible from the right SRB APU exhaust port prior to liftoff. This event occurred approximately five times. The source of this liquid is unknown. This event can be seen in Figure 2.

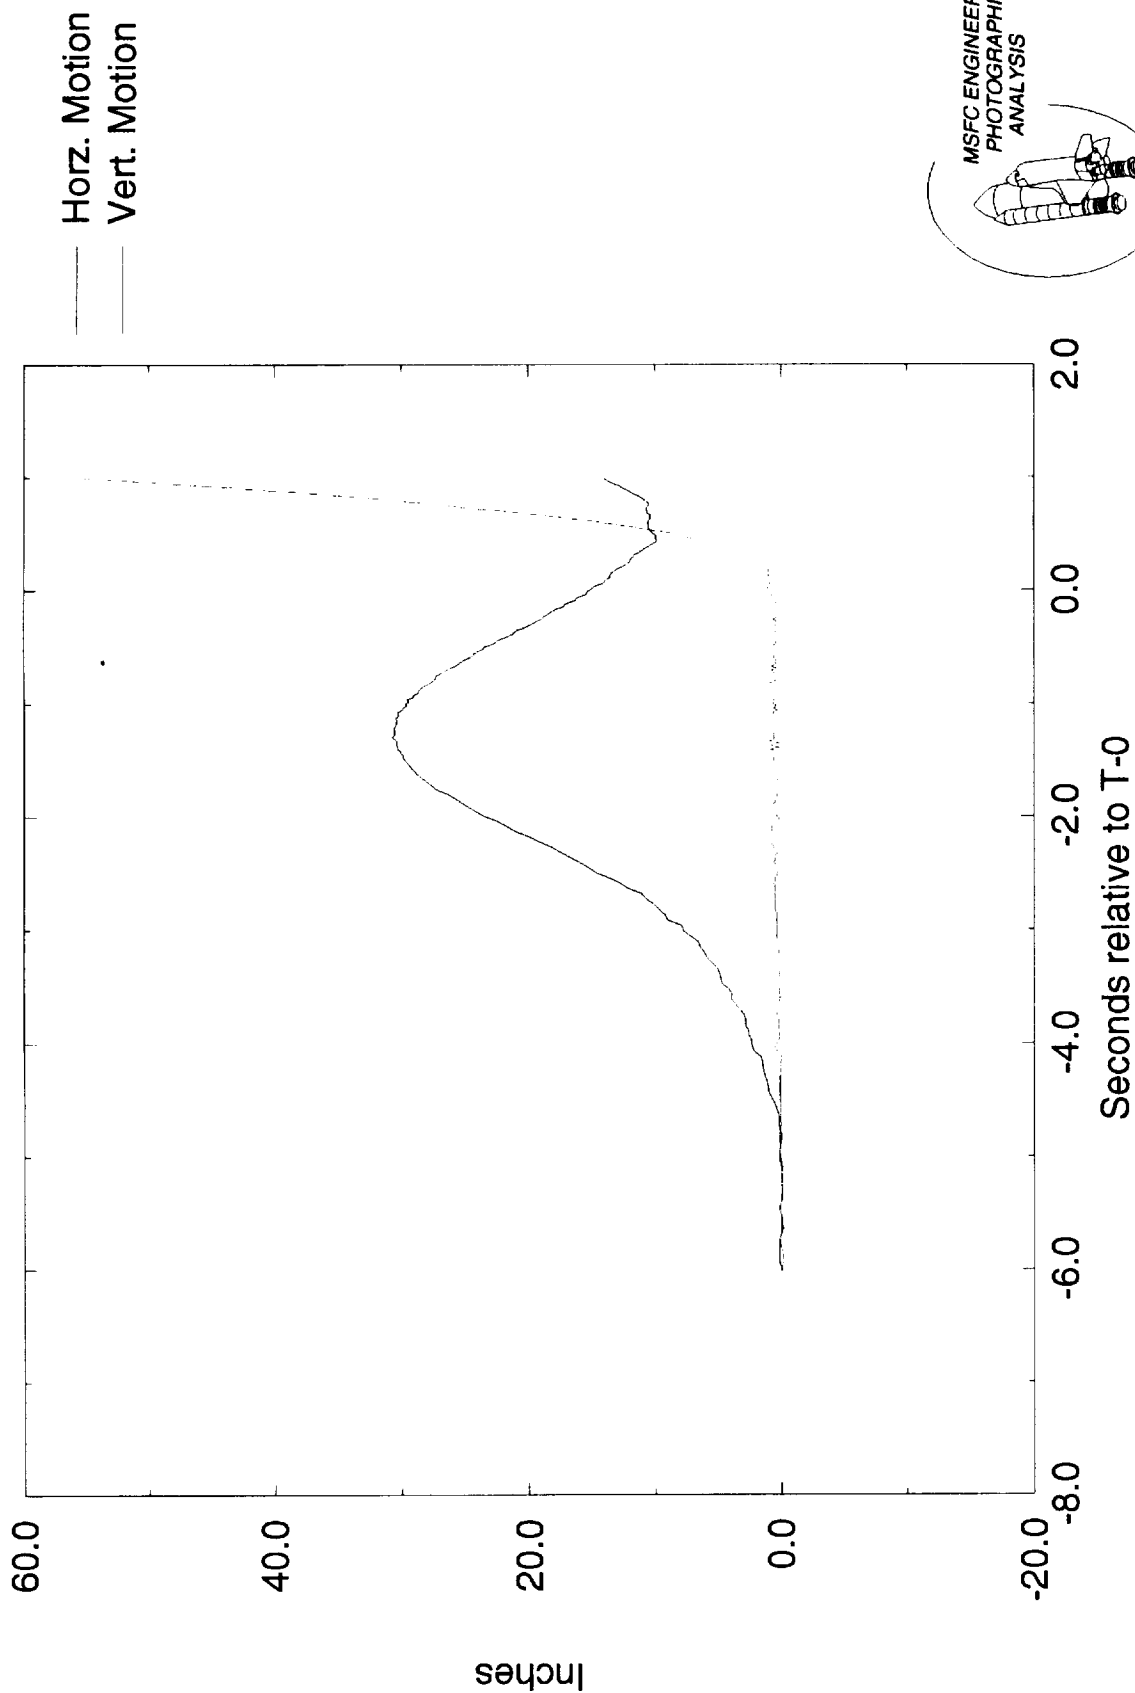
Figure 7 ET Tip Deflection

Maximum ET tip deflection for this mission was determined to be approximately 31 inches. Figure 7 is a data plot showing the measured motion of the ET tip in both the horizontal and vertical directions. A positive horizontal displacement represents motion in the -Z direction. These data were derived from film camera E-79.
